Coding Guide and Visual Demonstration of Google Gentrification Observation in Chicago^{1,2}

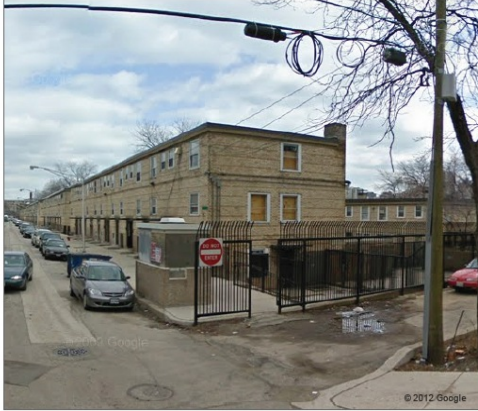
Example block face 1

Example Block Face 1: 803–869 N. Cambridge Avenue, Chicago, IL 60610 (East block face)

Block-face stage score: .41; Tract stage score: .47

L1. 1	N3. 0	B2. 0	D3. 0
P1. 0	N4. 0	B3. 1	G1. 2007/2009
N1. 0%	N5. 0	D1. 0	G2a. 1
N2. 1	B1. 1	D2. 1	G2b. No diff. bt yr

- Ex. 1: We coded this block face with a 0. We categorized all of the structures as older with a lack of modern design, no sandblasted brick, no new signage or walkways, and the presence of deteriorated brick. Furthermore, the deteriorated brick and basic design of

windows and frames, doors, and entryways, as well as the small size of units based on the spacing between exterior doors indicate these are not all well-kept, attractive, and sizeable units.

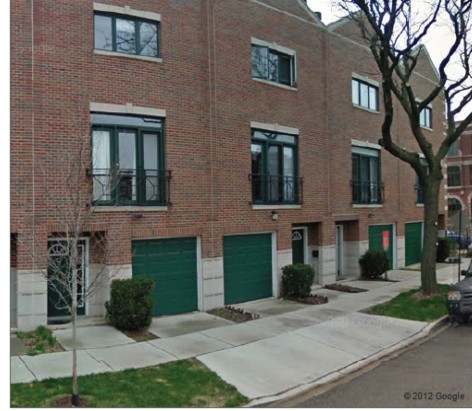
Example block face 2

Example Block Face 2: 508–579 N. Bishop Street, Chicago, IL 60642 (East block face)

Block-face stage score: .58; Tract stage score: .60

L1. 1	N3. 0	B2. 1	D3. 1
P1. 0	N4. 0	B3. 1	G1. 2009
N1. >50%	N5. 0	D1. 0	G2a. 0
N2. 1	B1. 0	D2. 1	G2b. n/a

- Ex. 2: We coded this block face with a 0. We categorized most of the structures as newer except for one tan house, due to its lack of modern design and sandblasted brick. This structure is well-kept and has some features that are beyond basic design or décor (e.g., window frames and entryway), but it appears to be a split-level home and is of modest size. One could arguably consider this home to be rehabbed within the past 10 to 15 years—with its newer entryway and window frames—and if this was the case, the block would still receive the same structural mix score. While relatively modest in design (rather than luxury), we categorized the townhomes in the image as newly constructed. Another apartment building on the street is difficult to distinguish between older and newer, but based on its sandblasted brick and the absence of peeling paint, no obvious structural repairs needed, and no deteriorated siding or brick, we categorized the building as having been constructed or rehabilitated within the past 10 to 15 years. Based on the one structure categorized as older, we therefore coded the block face with a 0.

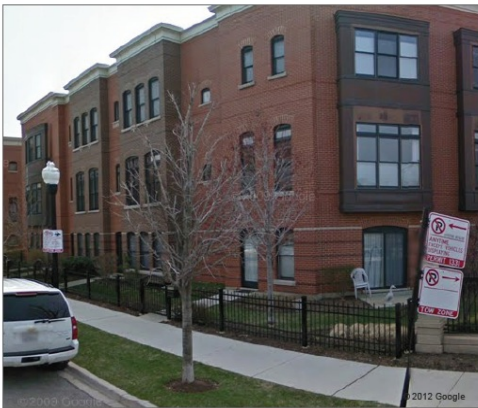
Example block face 3

Example Block Face 3: 1445–1519 S. Peoria Street, Chicago IL 60608 (West block face)

Block-face stage score: .88; Tract stage score: .75

L1. 0	N3. 1	B2. 1	D3. 1
P1. 0	N4. 1	B3. 1	G1. 2009
N1. >50%	N5. 0	D1. 1	G2a. 0
N2. 1	B1. 0	D2. 1	G2b. n/a

- Ex. 3: We coded this block face with a 0. We categorized all the structures as new based on the modern design, sandblasted brick, new entryways and walkways, absence of peeling paint, no obvious structural repairs needed, and no deteriorated siding or brick.

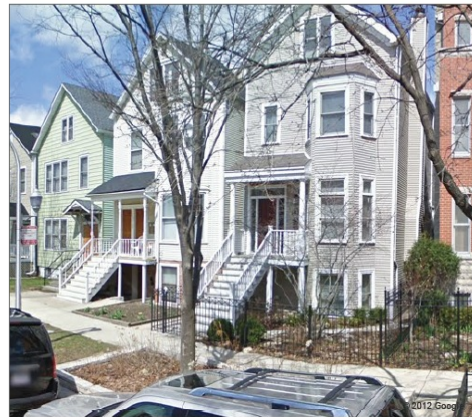
Example block face 4

Example Block Face 4: 1300–1386 W. Melrose Street, Chicago, IL 60657 (North block face)

Block-face stage score: .94; Tract stage score: .81

L1. 1	G2a. 0
P1. 1	G2b. n/a
N1. 11-50%	
N2. 1	
N3. 0	
N4. 0	
N5. 1	
B1. 0	
B2. 1	
B3. 1	
D1. 1	
D2. 1	
D3. 1	
G1. 2009

- Ex. 4: We coded this block face with a 1. We categorized a majority of the structures as older except for four houses with modern design and sandblasted brick. The homes we categorized as older were nearly all well-kept, attractive, and sizeable, with no peeling paint, no obvious structural repairs needed, and no deteriorating siding or brick; porches and balconies, windows and frames, doors, entryways, and walkways were beyond basic design or décor; and they were large enough to comfortably house a family. Only one home was modestly sized and lacked features beyond basic design or décor.

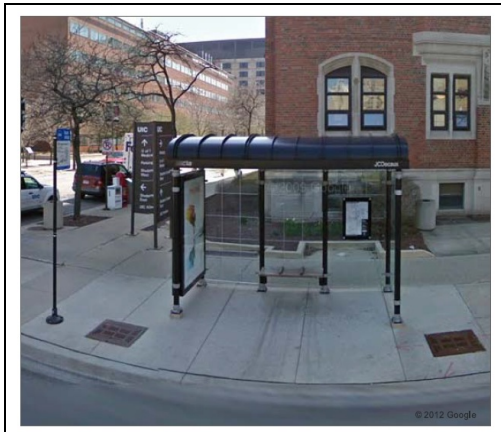
Fig. 1. Modern bus stop in Chicago
Address: 1809 West Polk Street

This indicator captures aspects of public reinvestment in public space. Public courtesies include bus stops or subway entrances, public seating, bike racks, public trash cans, newspaper stands, mailing depositories, and street lamps. “New” refers to signs and structures that appear to have been installed or rehabilitated within approximately the past 10 to 15 years, presumably by the city. Bright and unfaded paint without obvious repairs needed and modern design or décor (for bus stops, subway entrances, public trash cans, and street lamps) indicate new public courtesies. We consider vandalism as a separate indicator that does not affect how we code the age of public courtesies. Modern bus stops and modern public trash cans in Chicago appear as in Figs. 1 and 2 below. We did not find any new subway entrances = in the observed sample. Only Ex. 3 contains public courtesies—street lamps—that appeared new based on their bright and unfaded paint and modern design and décor.

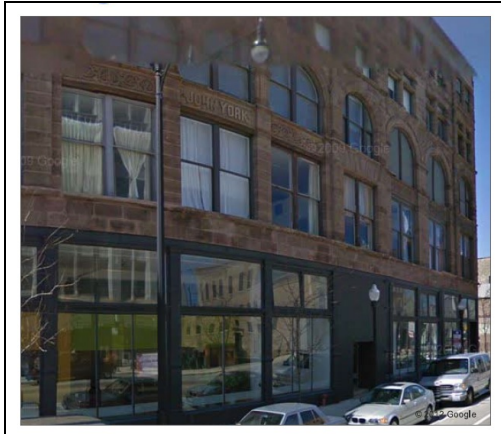
Fig. 3. Converted industrial use
Address: 1962 South Halsted Street

This indicator captures aspects of large-scale reinvestment. We coded block faces with a 1 if they contain new structures that are also luxury high-rise condominiums, large residential/commercial area developments occupying at least the entire block face, or converted industrial use to residential or commercial use. If the development consists of single-family dwellings or are low-rise, we only considered these as “large-scale” if they occupied at least 75% of the block face. Warehouse buildings being used for residential or commercial purposes based on the signage, entryways, and walkways indicate converted industrial land use (see Fig. 3). See earlier description for “new” building structures. If all structures were considered “old,” the block face received a 0 for this indicator. Signage, entryways, and walkways beyond basic design or décor indicate new luxury condos (see Fig. 4). Homogeneous architectural design with signage, entryways, and walkways beyond basic design or décor and that occupy at least the predominant land use of the block face indicate new large residential and commercial developments. We also included areas under construction in which signage indicated this land use. Only Ex. 3 has a new large residential development, which occupies the entire block face.

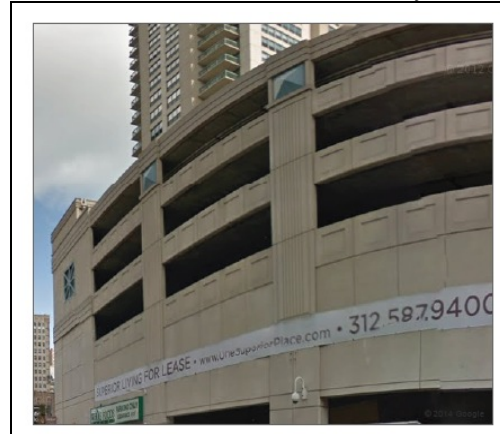
Fig. 4. Luxury high-rise condominiums
Address: 705 North Dearborn Parkway

This indicator captures aspects of recent reinvestment by outside investors or developers, that is, not by residents themselves. We coded block faces with a 1 if they contain new structures that are also for sale or lease (not rent) based on signage (e.g., Fig. 4). See description for “new” building structures from item P1. If all structures were considered “old,” the block face received a 0 for this indicator. We also included areas under current construction that were for sale, as indicated by signage. Only Ex. 4 contains a residential unit in new condition for sale.
